WI-584
Richardson Building
Salisbury
Private

Maryland Inventory of Historic Properties Form

historic Richardson Building

street and number 130 East Main Street not for publication

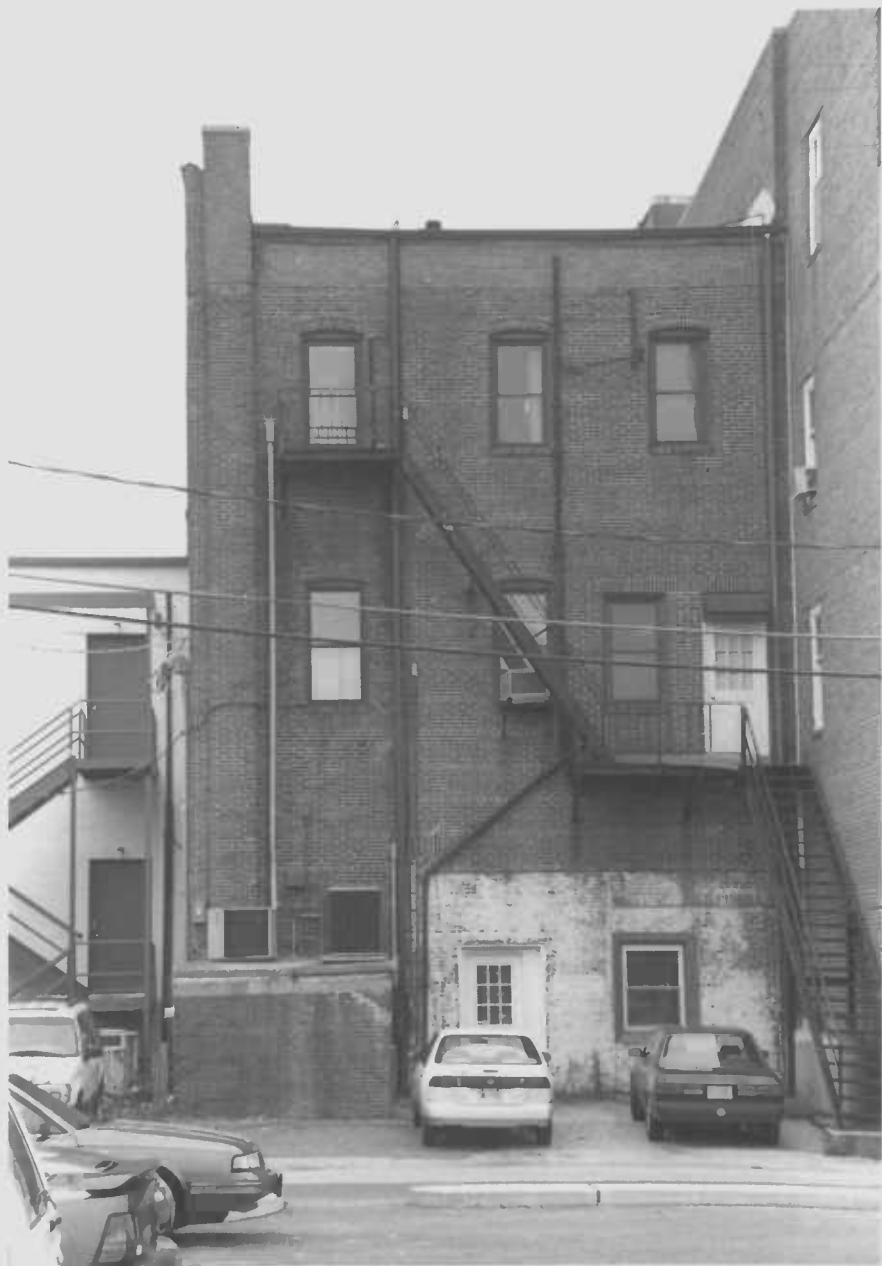
2 OF 2

SOUTH ELEVATION

The south and west walls are pierced by window openings, most of which have double rowlock segmental arches. A tall furnace flue rises on the southwest corner of the building.
